RCRA COMPLIANCE EVALUATION INSPECTION REPORT

SITE NAME: MODERN DAY MINING & REFINING

EPA ID NUMBER: OHD004469300

DATE OF INSPECTION: March 12, 2013

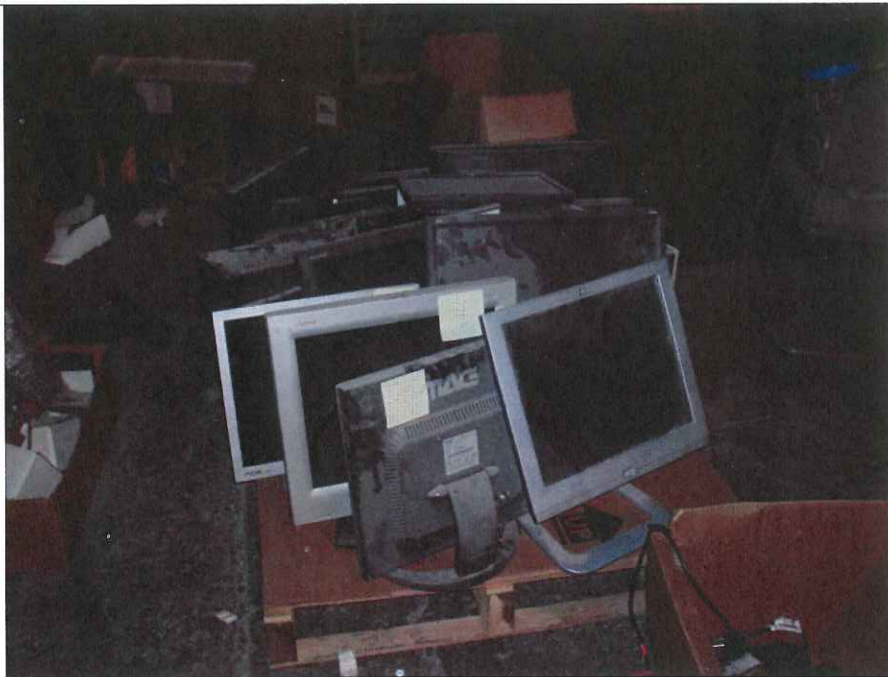
Picture #: P3120065

Subject: These computer monitors are labeled with post-it notes stating the evaluated condition.

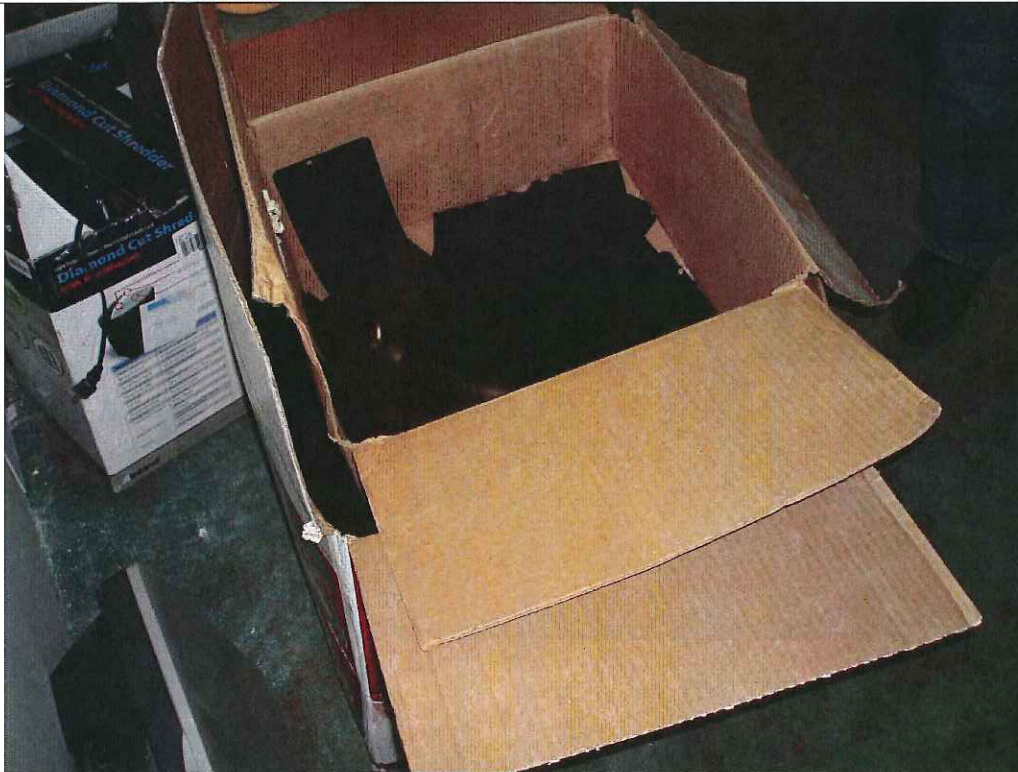
P3120066

Subject: The black plastic strips are an example of the industrial xray film from which MDMR expects to reclaim silver.

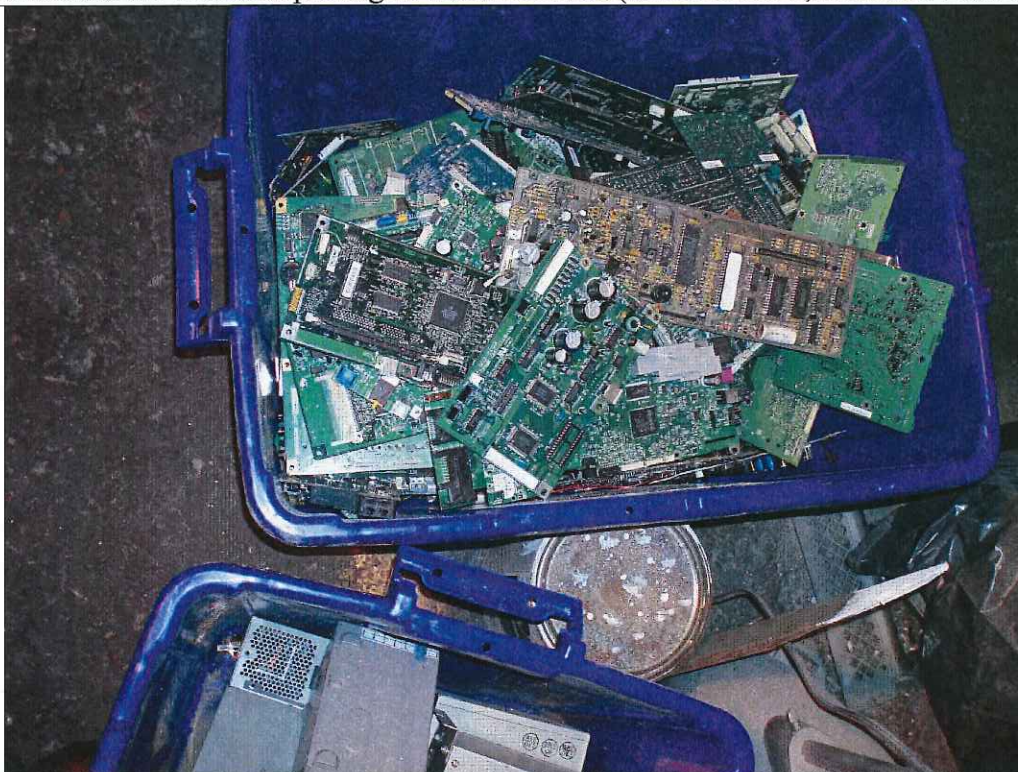
P3120068

Subject: This bin contains boards with a variety of electrical parts containing precious metals. The bin is about two feet wide by three feet long.

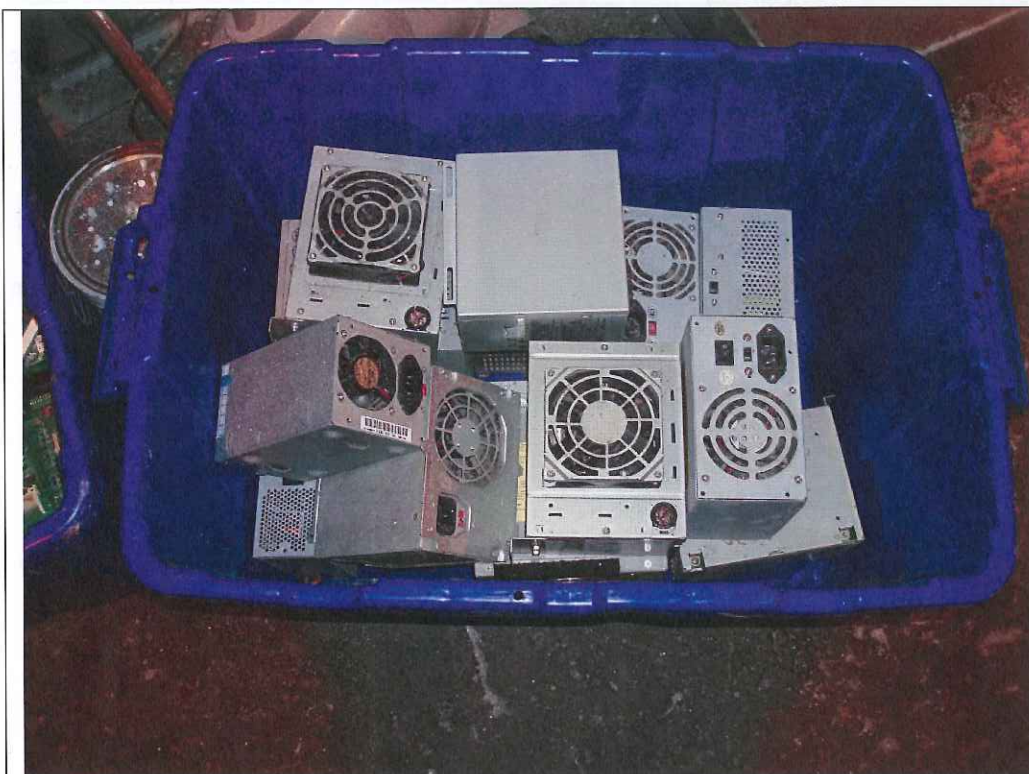
Picture #:
P3120069
Time: 1:18
Location:
OHD004469300
Subject:
Similar-looking
electrical parts
to be recycled

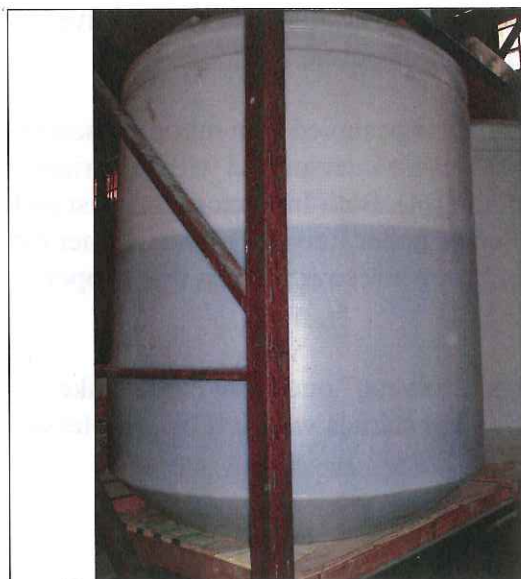
As the tour proceeded north along the east side of the building, I observed the pilot plant for batch silver reclamation from used x-ray film. The pilot plant consisted of two large vertical cylindrical elevated tanks, one with a mixer/stirrer (photos P3120070 and P3120071), one square tank and two smaller vertical cylindrical tanks. The square tank and two smaller cylindrical tanks are placed on the floor.

Picture #: P3120070
Time: 1:24 p.m.
Location: OHD004469300, east side of leased building.
Subject: Looking east northeast at a large vertical plastic tank that is part of the batch pilot plant for silver reclamation from x-ray film. The fluid level in the tank is easily seen about halfway between tank top and tank bottom. The tank is elevated on a platform above the concrete floor. I estimate the tank height as 6 feet and the diameter as 4 feet. The volume for a 45° cone bottom tank with those dimensions is 500 gallons (www.plastic-mart.com).

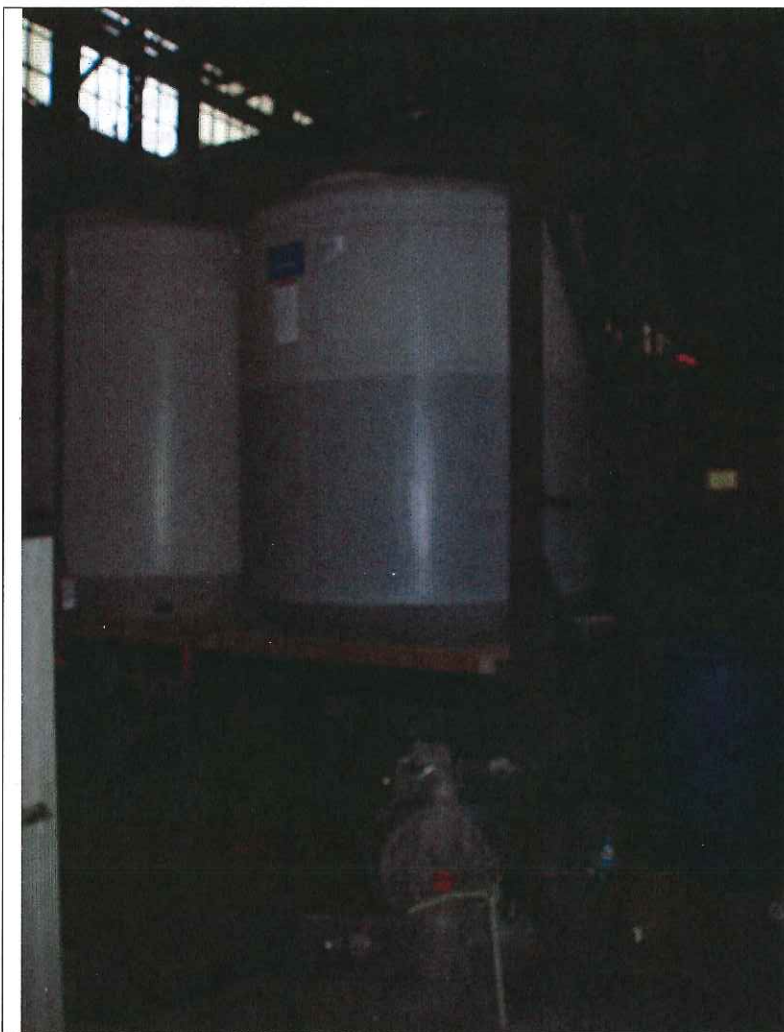
Picture #: P3120071

Subject: Looking southeast at the same large pilot plant cone-bottom processing tanks seen in P3120070. Note the tank stirrer motor installed above the western tank. A one ton crane is overhead. An air diaphragm pump is installed below the tank platform. Unfortunately, the tank labels are not legible in this photograph. There is a blue plastic 55-gallon drum (about three feet tall by 2 feet in diameter) on the lower right for scale. The platform is about four feet above the ground.

The two smaller cylindrical tanks and square tank (volume est. as 300 gallons by me) are to the left, closer to the east wall. According to Mr. Brian Stimer, the same "water" can be used five times, then it is no longer effective and has to be neutralized and disposed.

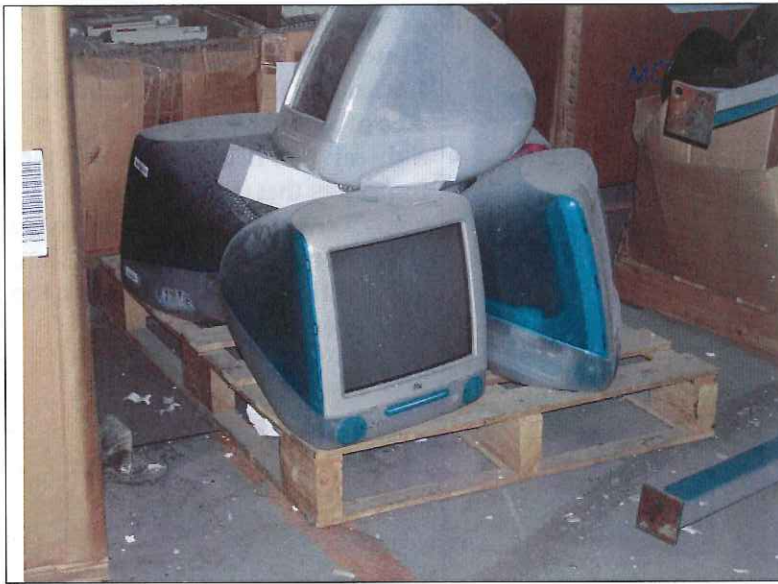
Picture #:
P3120072
Time: 1:37 pm
Location:
OHD004469300,
central area of
leased building.
Subject: There
is no
distinguishing
labeling to
indicate
whether these
will be reused
or dismantled
for
reclamation.

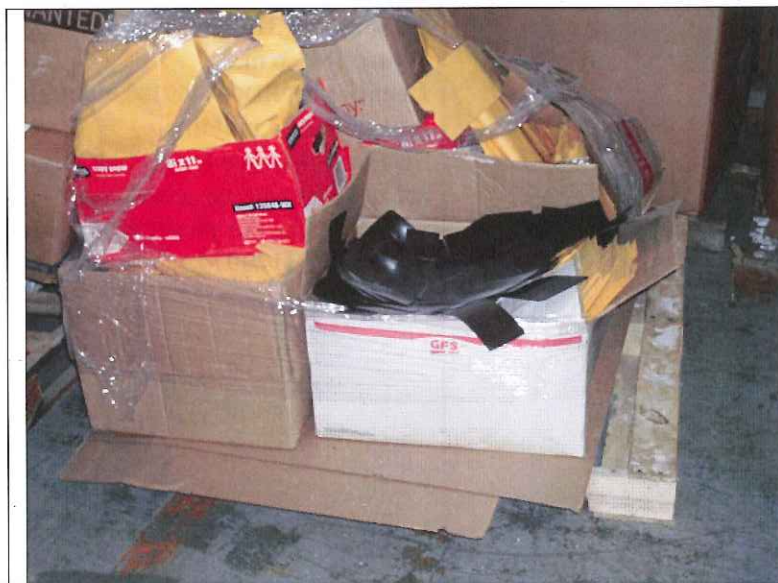
Picture #: P3120073
Time: 1:40 pm
Location: OHD004469300, central
area of leased building.
Subject: The black strips of plastic
are x-ray films. Some films are still
in protective manila paper sleeves.

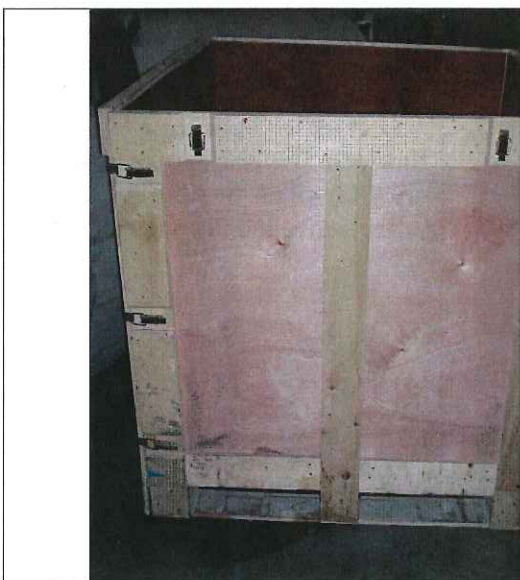
Picture #: P3120075

Subject: Wooden crates like this are used to manage processed materials like the plastic from film shown in P3120074.

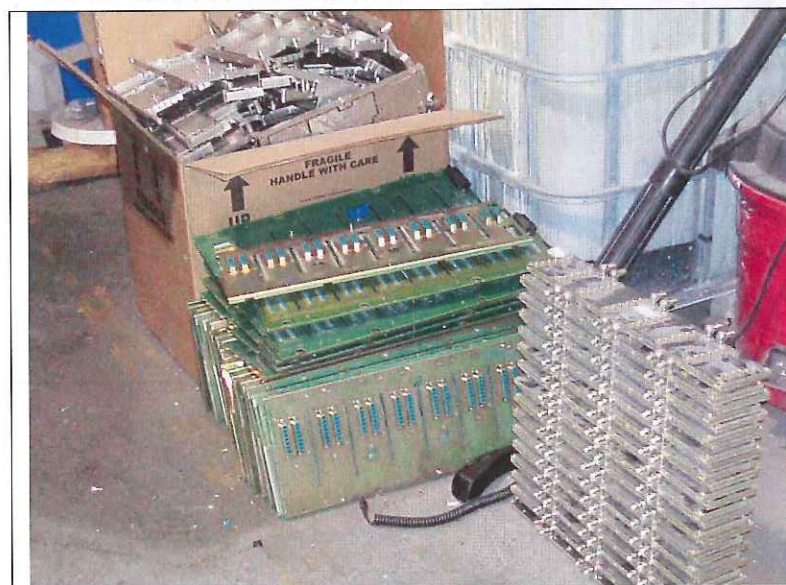
Totes of used liquids are adjacent to sorted metals and boards. See P3120077, 3120078 and 3120079, a left-to-right scene. Mr. Brian Stimer identified the "waste rinse water" totes shown below (P3120077 and P3120078) as used and going to be used again. The totes were used by Mike Rock of Roko Alloys according to Mr. Brian Stimer.

Picture #: P3120077
Time: 1:43 p.m. **Location:** central area of OHD004469300
Subject: Metals are physically separated from circuit boards at MDMR, as shown here. Note tote and shop vac.

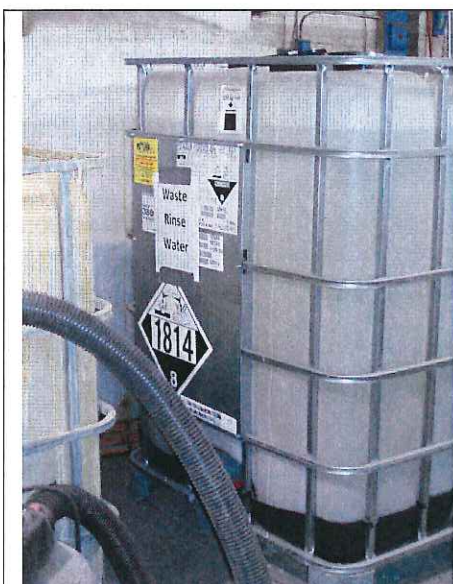
Picture #: P3120078

Subject: Mr. Brian Stimer identified the contents of this tote as potassium hydroxide waste rinse water.

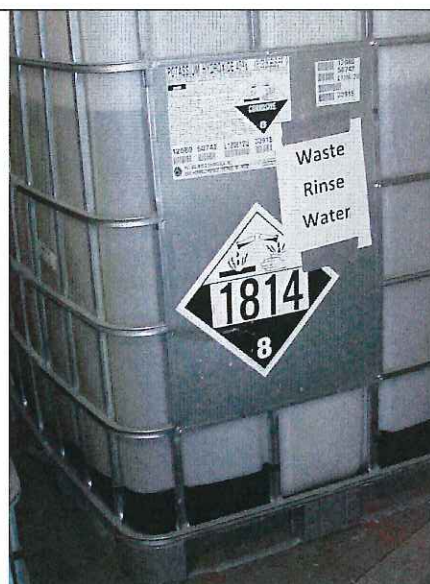
Picture #: P3120079

Subject: This is a second tote of the same waste as shown in P3120078

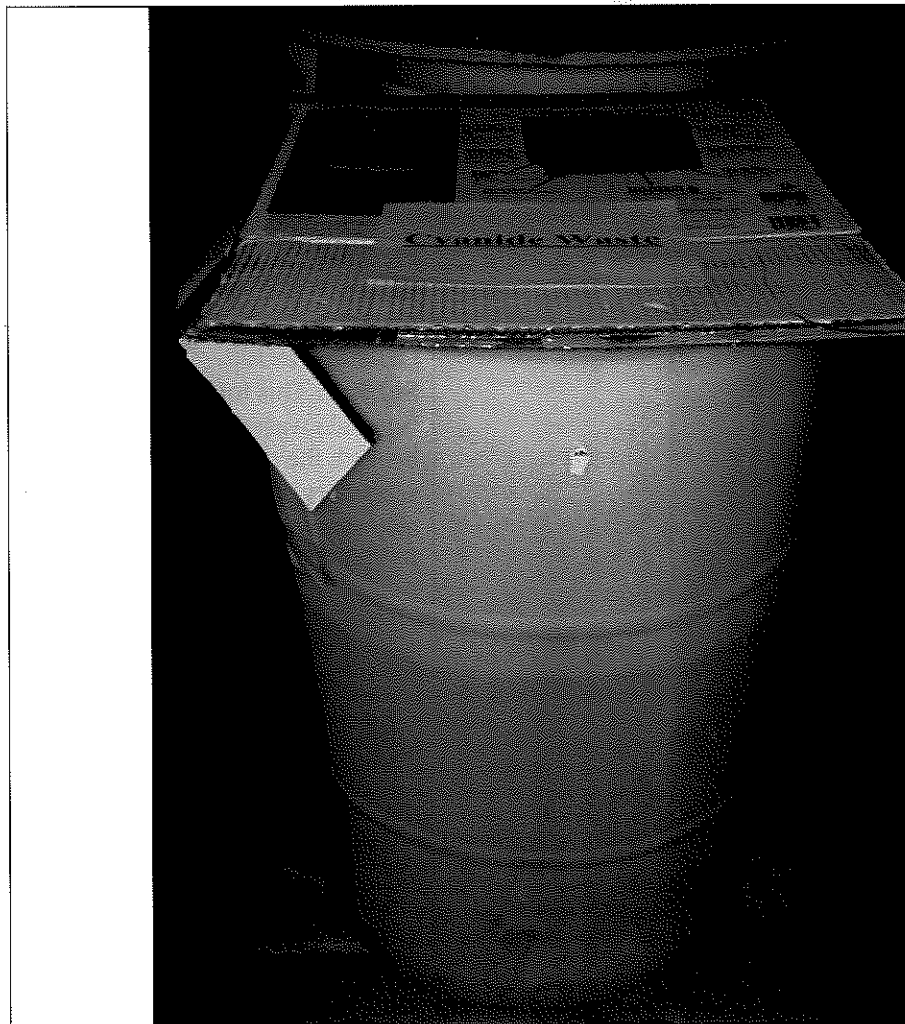
Picture #: P3120082

At the time of the inspection, Modern Day Mining & Refining did not keep its 55-gallon drums of cyanide-containing waste closed during storage. Waste was not being added or removed to these 55-gallon drums while they were open.

Subject: This drum labeled, "Cyanide Waste," is 3/5 full. The open top of the drum is not closed. It is covered with a flattened cardboard box.

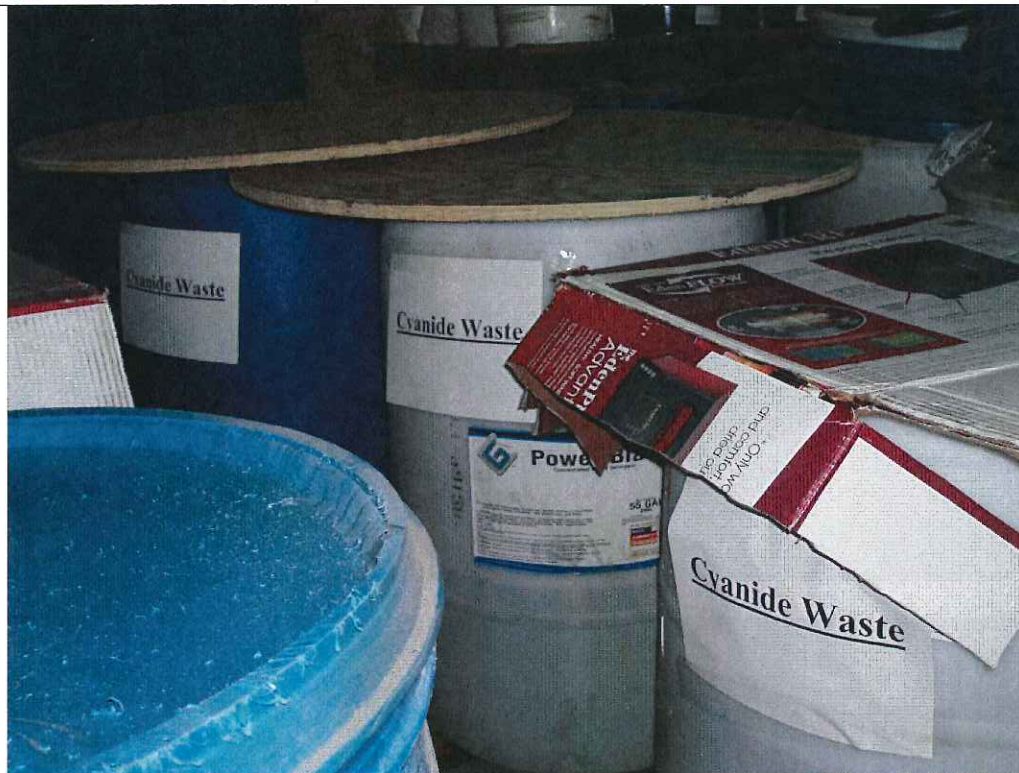
Picture #: P3120083
Time: 1:57 p.m.
Location: central area of OHD004469300
Subject: These drums labeled "Cyanide Waste" are not closed, except for the blue drum in the bottom left corner of the photograph. The open-top drums are covered by round pieces of plywood or flattened cardboard boxes. This group of drums is also shown in P3120082.

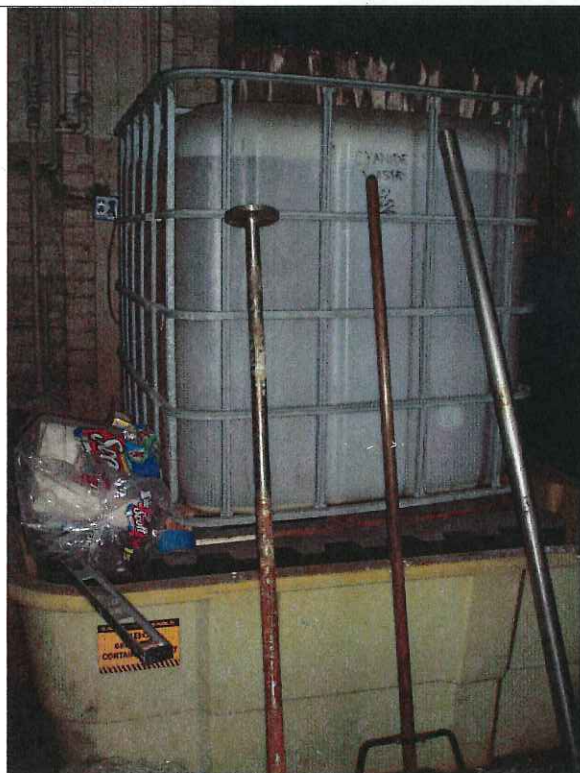
Picture #: P3120084
Time: 1:58 p.m.
Location: central area of OHD004469300
Subject: This tote is nearly full of "cyanide waste." The pallet beneath the tote is above the secondary containment. This tote is also shown in photograph P3120085.

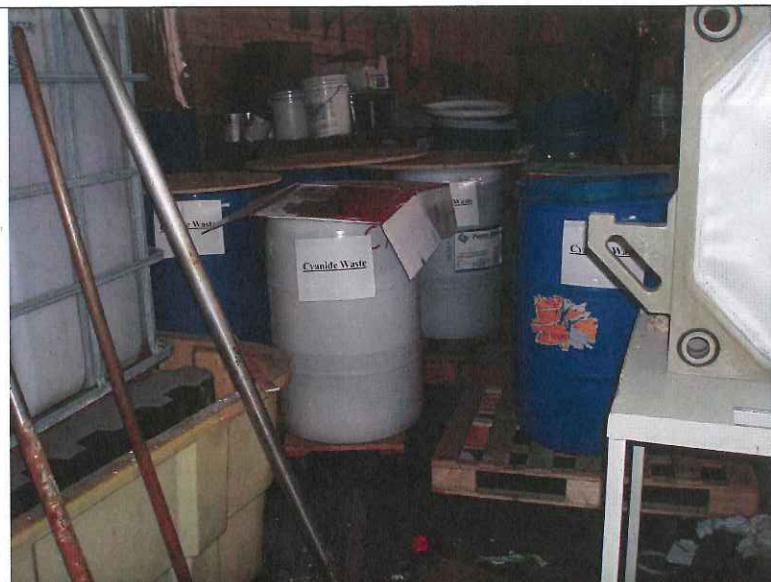
Picture #: P3120085

Subject: The four drums shown are in a group of six partially full drums labeled, "cyanide waste." According to Mr. Brian Stimer, this liquid can be reused. I lifted the covers and saw open top drums. The open top drums are covered by circular pieces of plywood or, in the example of the white drum in the center of this photograph, covered with a flattened cardboard box. There is no secondary containment beneath the wooden pallet.

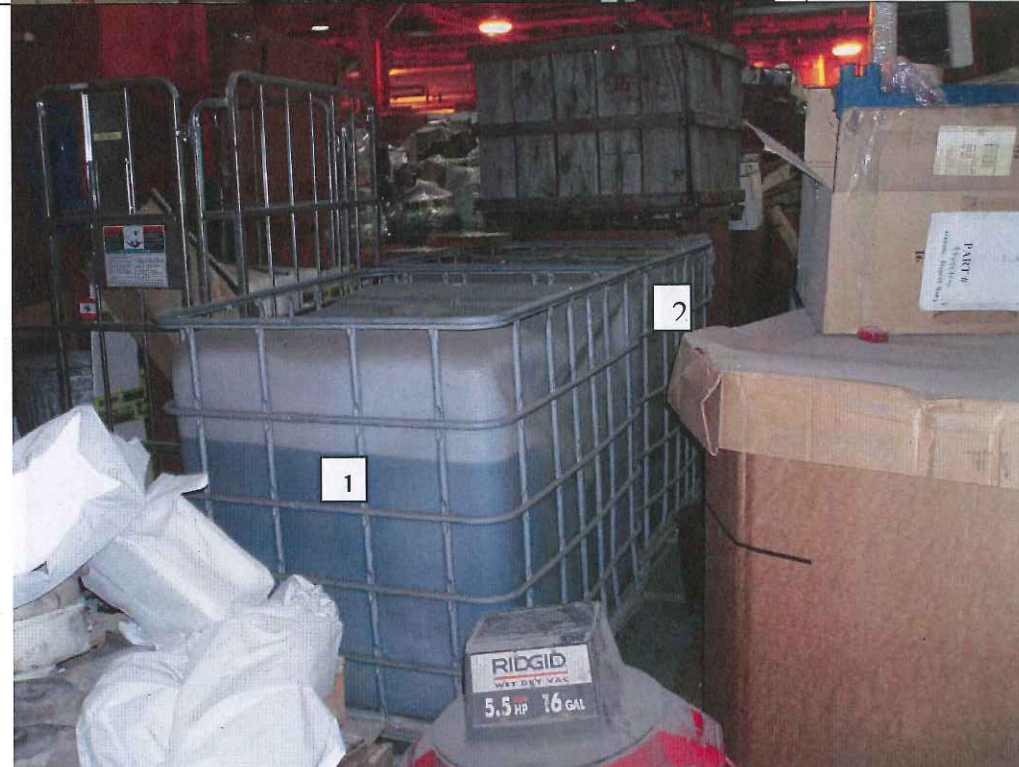
Picture #: P3120086

Subject: According to Mr. Brian Stimer: the two totes contain fluid that removes Cosmolene²³; Mike Rock flies all over buying jet motors; Cosmolene gets on jet turbines; this fluid removes the Cosmolene and is a reusable product.

Mr. Brian Stimer told the inspectors that Mr. Mike Rock of Roko Alloys was a sublessor until "the week before last." Mr. Brian Stimer explained that 500 gallons of the fluid is placed in a heated tank to strip jet parts.

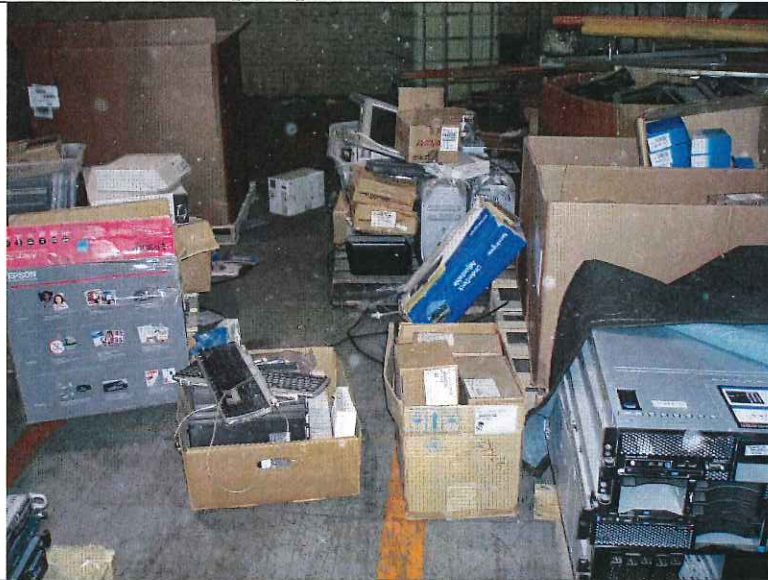
Picture #: P3120087
Time: 2:12 p.m.
Location: central area of OHD004469300
Subject: Various electronic parts waiting to be sorted include servers in the right foreground and boxes of keyboards left of central foreground.

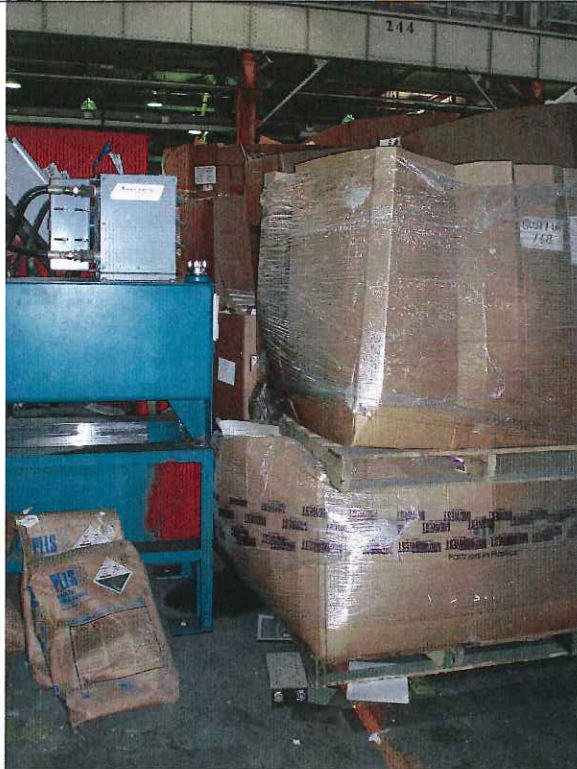
Picture #: P3120088 **Time:** 2:13 p.m.
Location: central area of OHD004469300
Subject: There are bags of product potassium hydroxide (KOH) on the floor to the left. The industrial machinery on the left side belongs to Mike Rock according to Mr. Brian Stimer. The bulging, shrink-wrapped boxes (2 rows of pallets, 2 boxes high) on the right contain medical records.

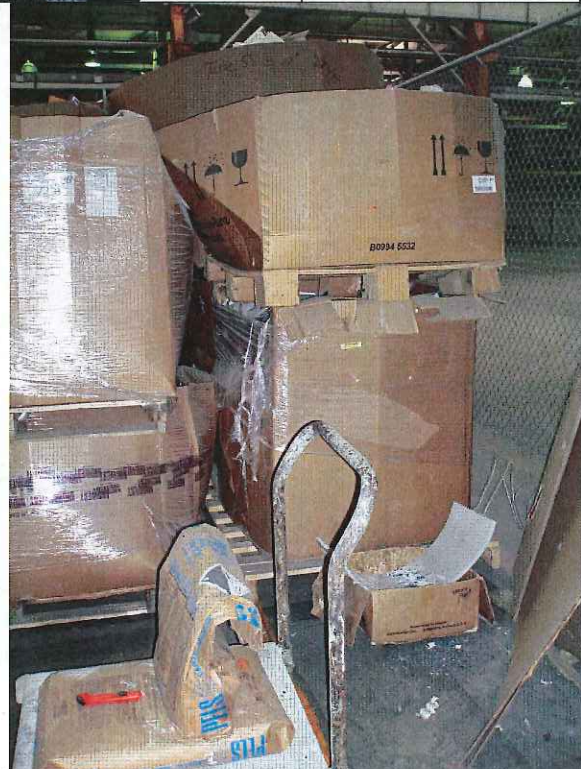
Picture #: P3120089 **Time:** 2:14 p.m.
Location: central area of OHD004469300
Subject: The right side of P3120088 overlaps with the left side of this photograph. The cyclone fence at the right separates the leased area from the area that MDMR has an option to lease. The fence runs east-west. The boxes contain records and x-rays.

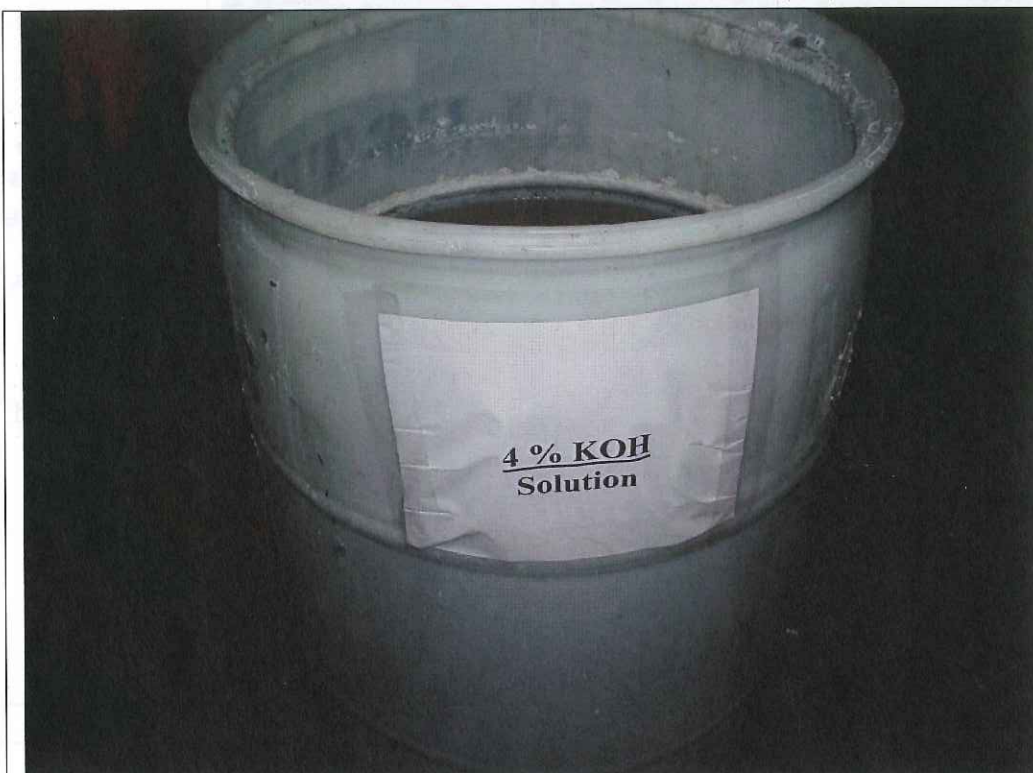
Picture #:
P3120090
Time: 2:20
p.m.
Location:
northern end of
OHD004469300
Subject: Mr.
Brian Stimer
said that the 55-
gallon drum of
4% KOH
solution was
from a "no
heat"
experiment.

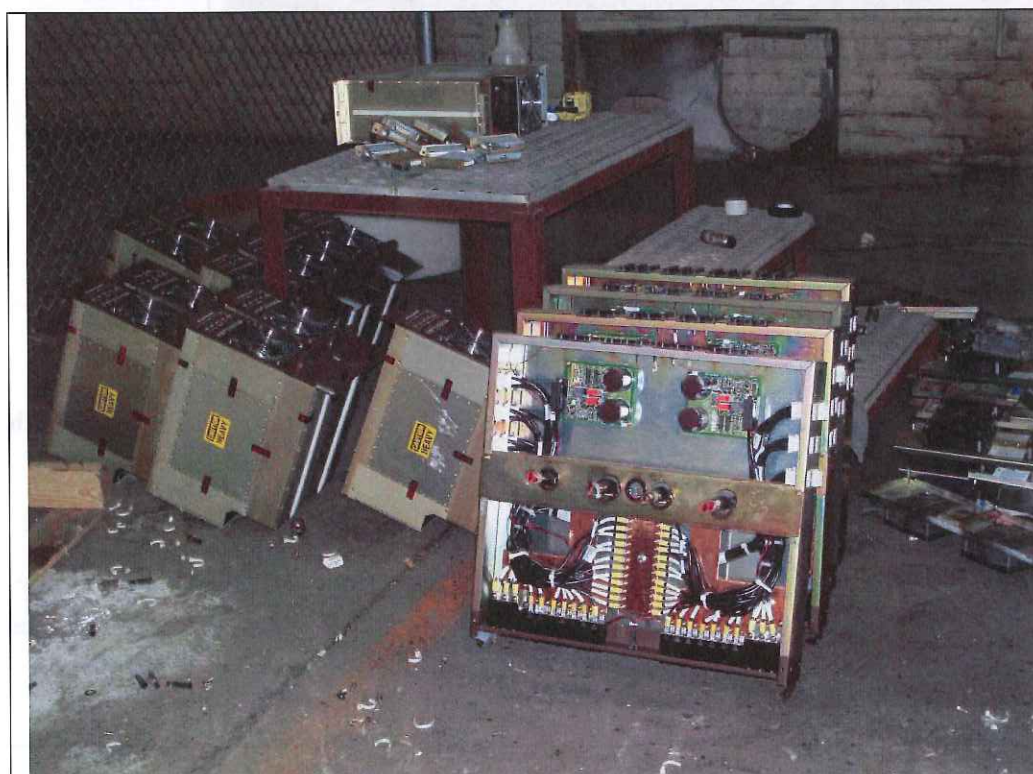
Picture #:
P3120091
Time: 2:21
p.m.
Location:
northeastern
corner of
OHD004469300
operations
Subject:
Electronics to
be recycled.

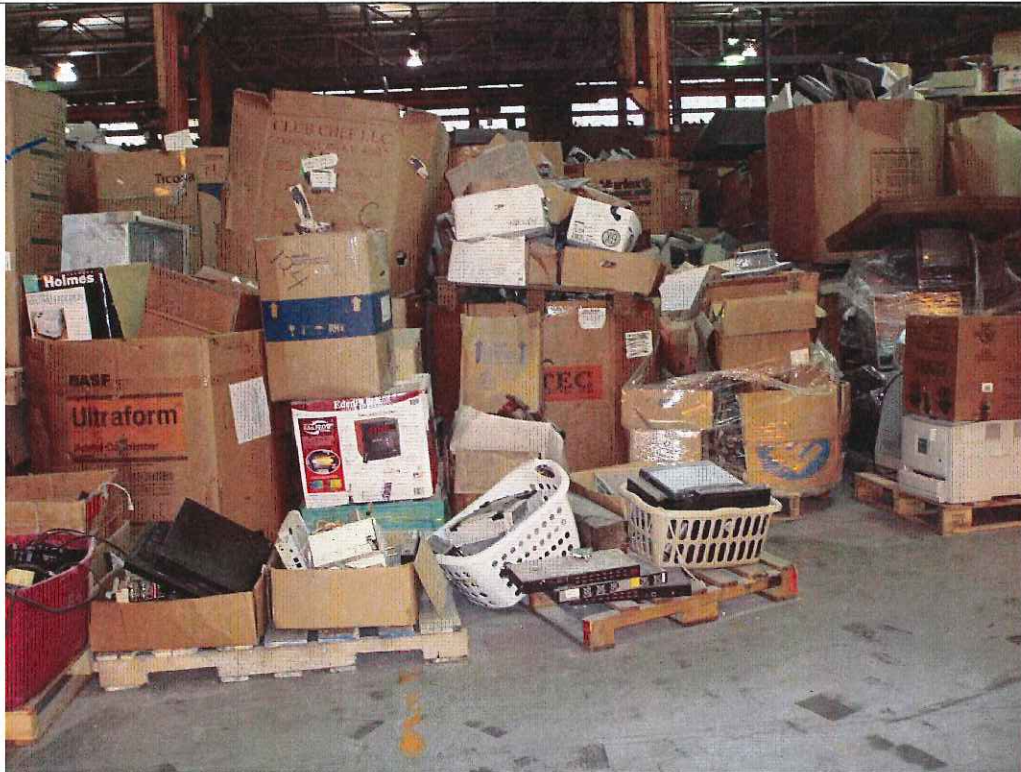
P3120092

central area of
OHD004469300
from western aisle

Subject: Boxes
of scrap waiting
to be sorted
include laptops,
flawed or
returned Eden
heaters,
humidifier, and
plastic cases.

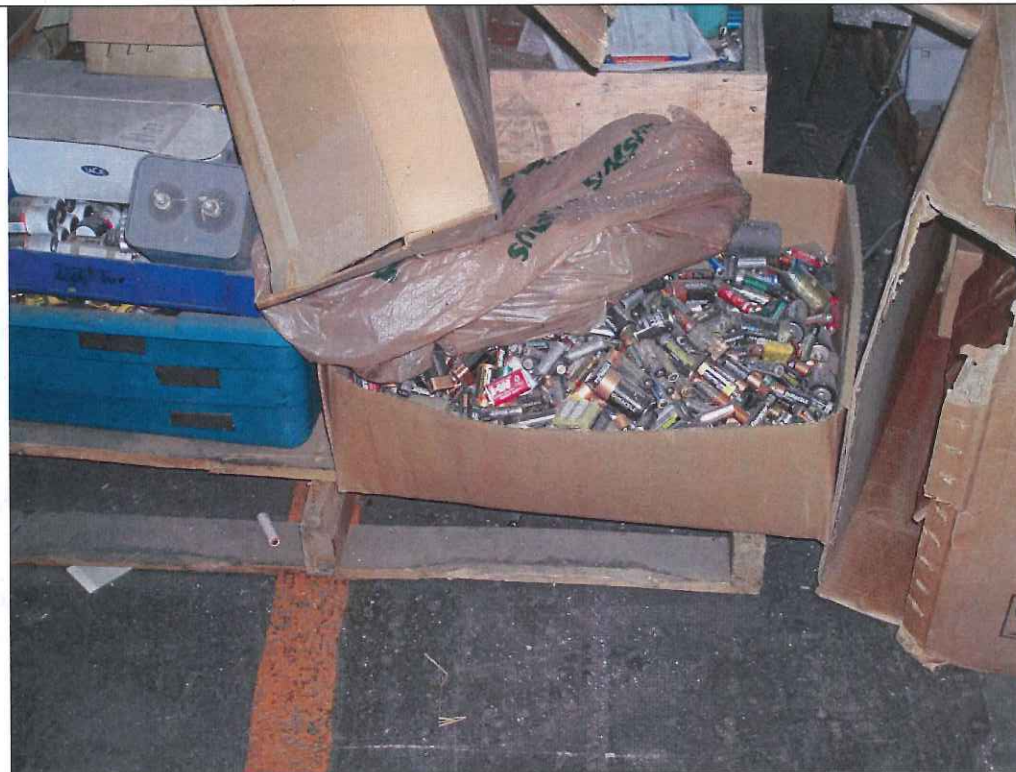
Picture #:
P3120094
Time: 2:34
p.m.
Location:
central area of
OHD004469300
Subject: Boxes
of batteries
have to be
sorted.
Inspector
Almquist
informed Mr.
Stimer that
MDMR may
have to pay to
dispose of the
alkaline
batteries.

Mr. Brian Stimer stated that he gets money for the nickel-cadmium and lithium batteries. Mr. Brian Stimer asked when PCBs were no longer allowed in manufactured items. He had just purchased 1500 switches manufactured in 1978.

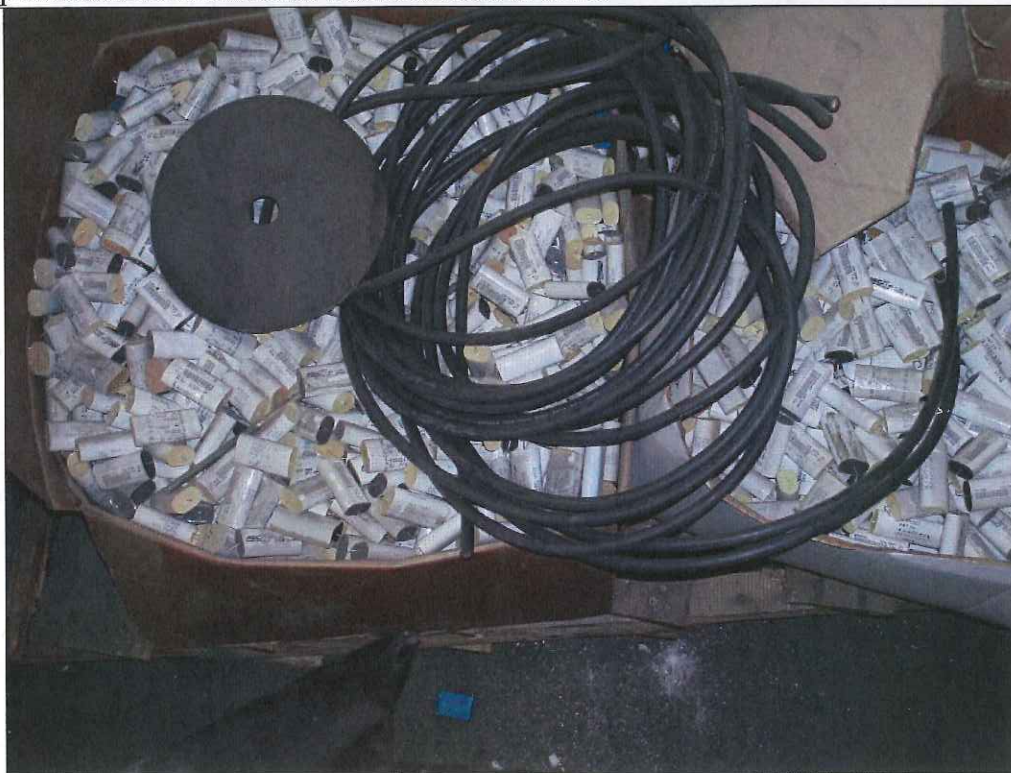
Picture #:
P3120095
Time: 2:40
p.m.
Location:
central area of
OHD004469300
Subject: Boxes
of electrical
part B32231.
According to
the results of a
post-inspection
Google search
for "B32231,"
these are
metallized
polyester film
capacitors. The
cable has a
copper core,
based on color.

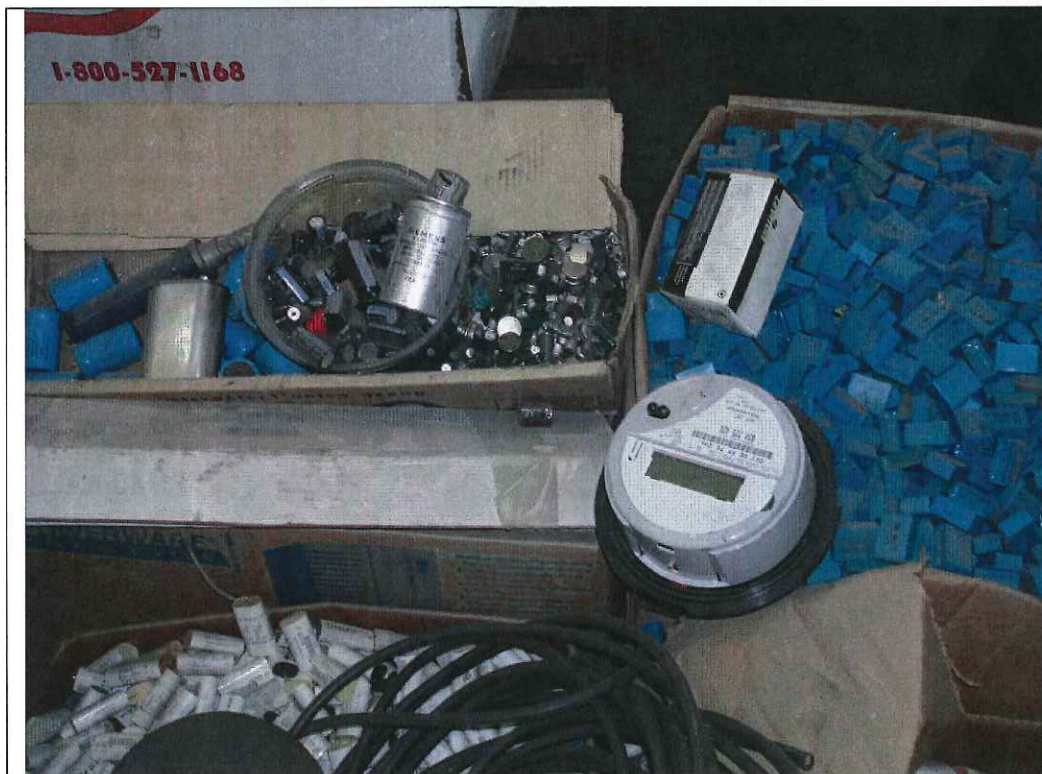
Picture #:
P3120096
Time: 2:40
p.m.
Location: west
aisle, central
area of
OHD004469300
Subject: Boxes
of various
electrical parts,
including a
Watt Hour
meter, batteries,
and capacitors.
The white
capacitors at the
bottom are the
same as shown
in P3120095.

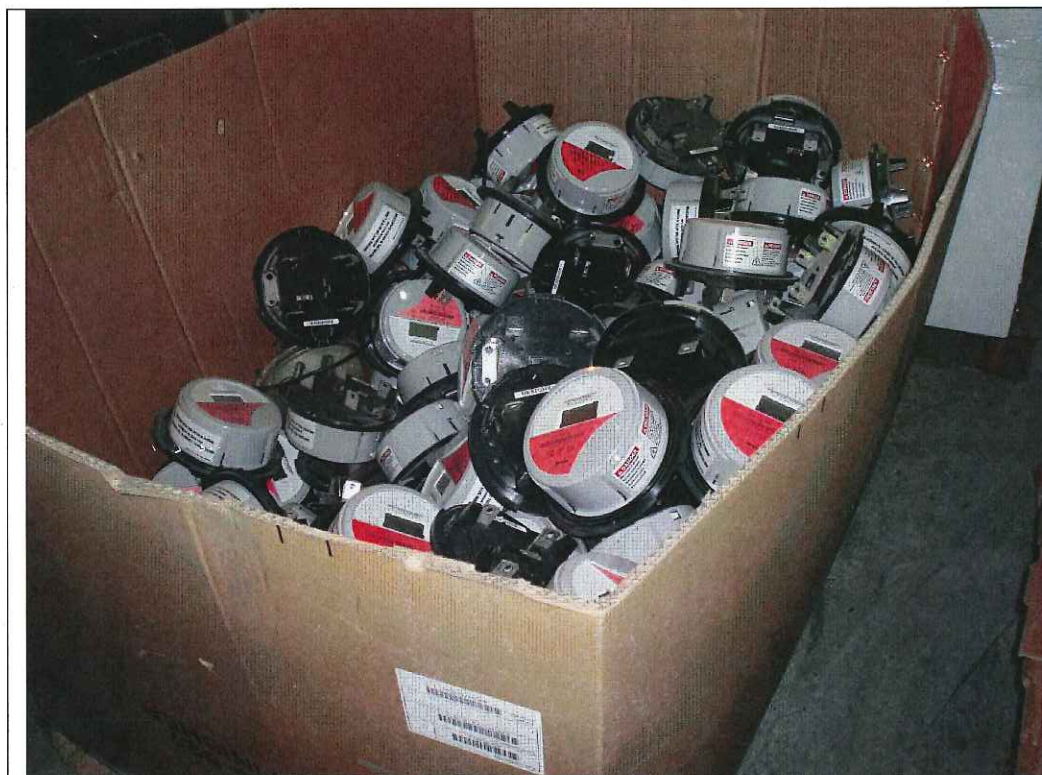
Picture #:
P3120097
Time: 2:45
p.m.
Location: west
aisle, central
area of
OHD004469300
Subject:
American
Electric Power
(AEP)
performed a
meter change-
outs. MDMR
obtained the old
meters.

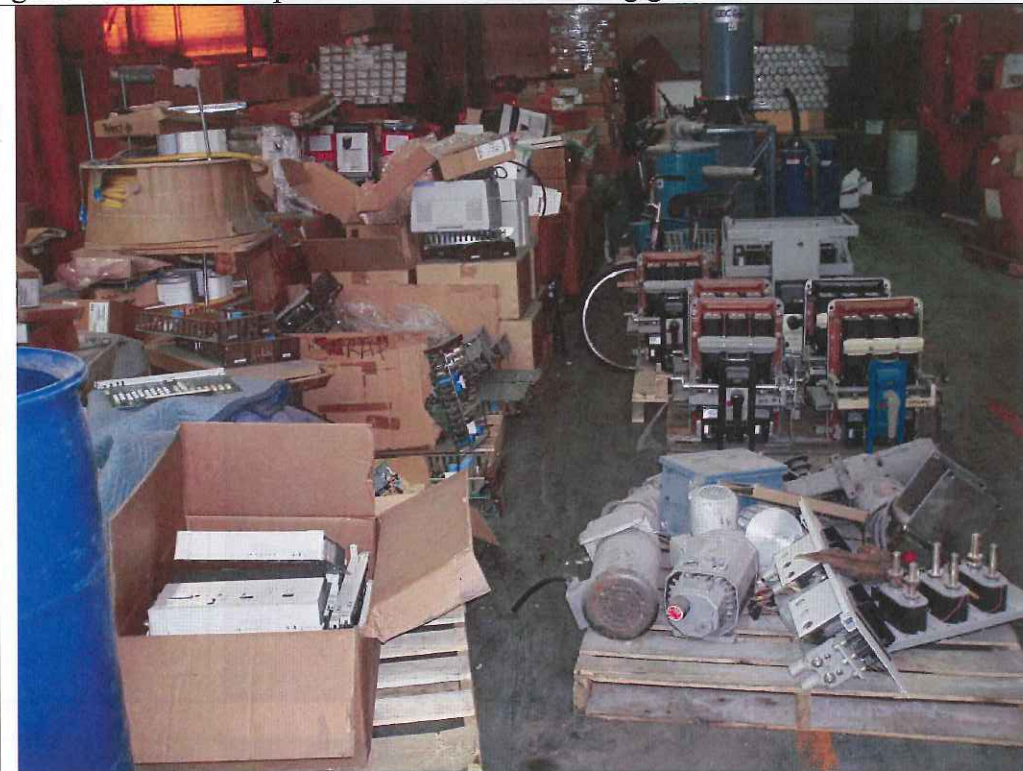
Picture #:
P3120098
Time: 2:46
p.m.
Location:
central area of
OHD004469300
Subject: The
wide variety of
electrical
components,
including scrap
motors and
paper
shredders,
received by
MDMR is
shown in this
photo. Also, a
lot of sorting
remains to be
done.

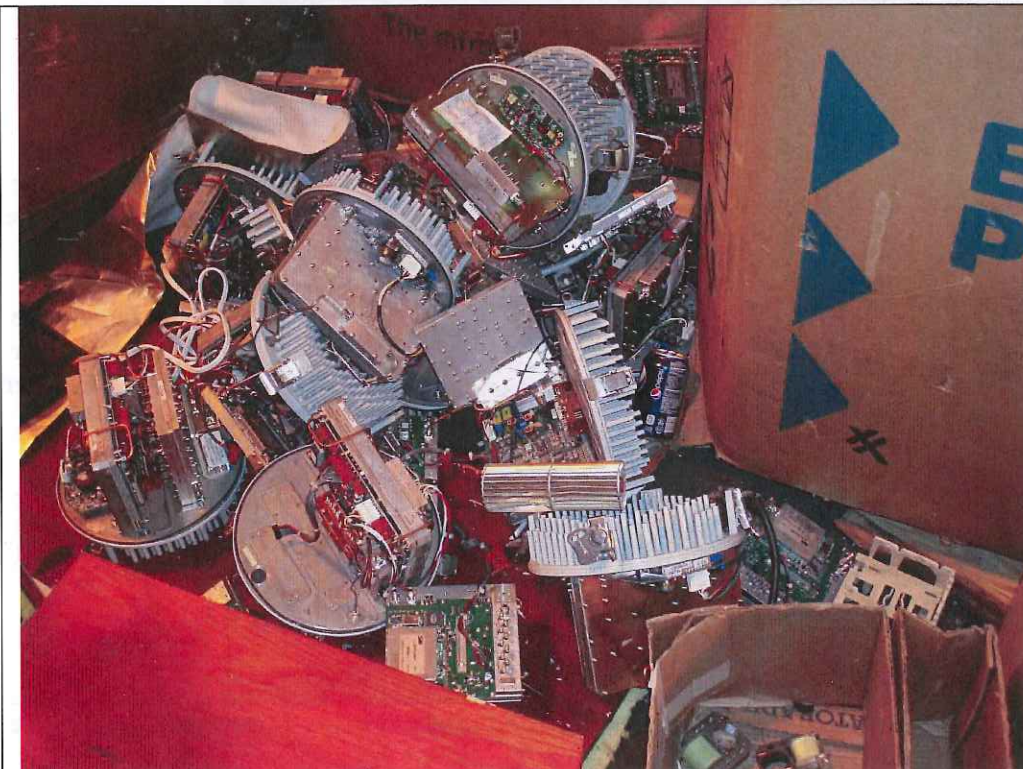
Picture #:
P3120099
Time: 2:51 p.m.
Location:
central area of
OHD004469300
Subject: Mr.
Brian Stimer
identified the
larger parts as
microwave
amplifiers.

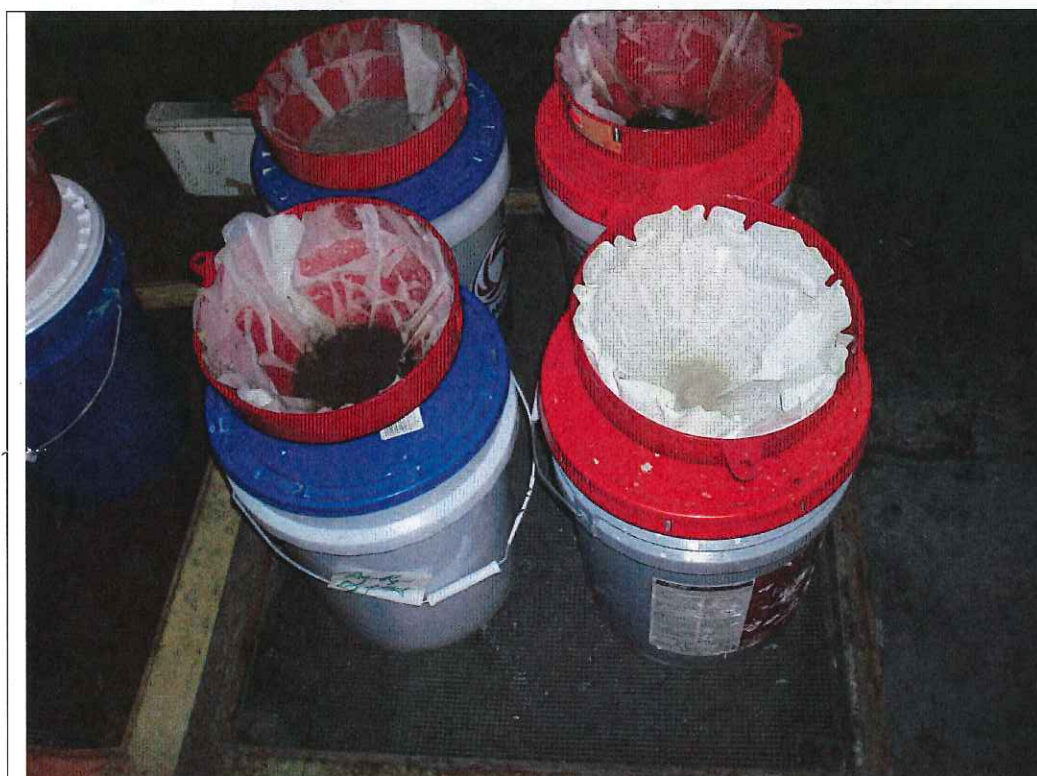
Picture #:
P3120101
Time: 3:01
p.m.
Location:
central area of
OHD004469300
Subject: These
four buckets are
on secondary
containment.
The funnels are
lined with filter
paper. The filter
paper holds
reclaimed
precious metal.

The reclaimed metal can be melted in a countertop muffle furnace on-site. I observed the furnace and remember it being smaller than 3' by 3' by 3'.

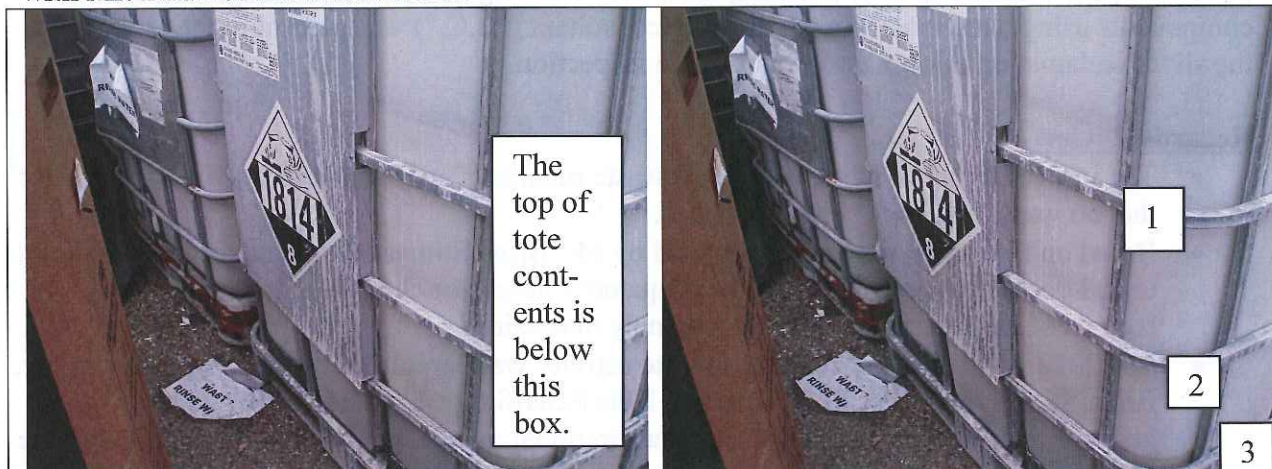
Picture #: P3120102

Location: At the yellow arrow on the site map at the beginning of the Site Tour section of this report.

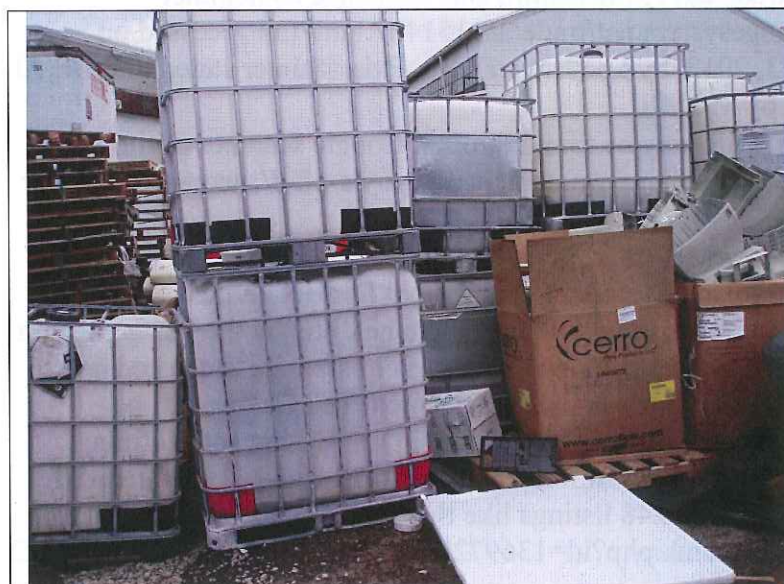
Picture #: P3120104

Subject: Same tote as in P3120102. Note that the tote is darker below the third-down horizontal metal bar.
